# Analysis of the Power Plant Breakwater Failure Subjected to Typhoon Mangkhut Based on Model Experiment

Qie Lu-wen<sup>1</sup>, Wang Chao<sup>1,2</sup>, Luan Ying-ni<sup>2</sup>, Chen Song-gui<sup>2</sup>, Chen Han-bao<sup>2</sup>

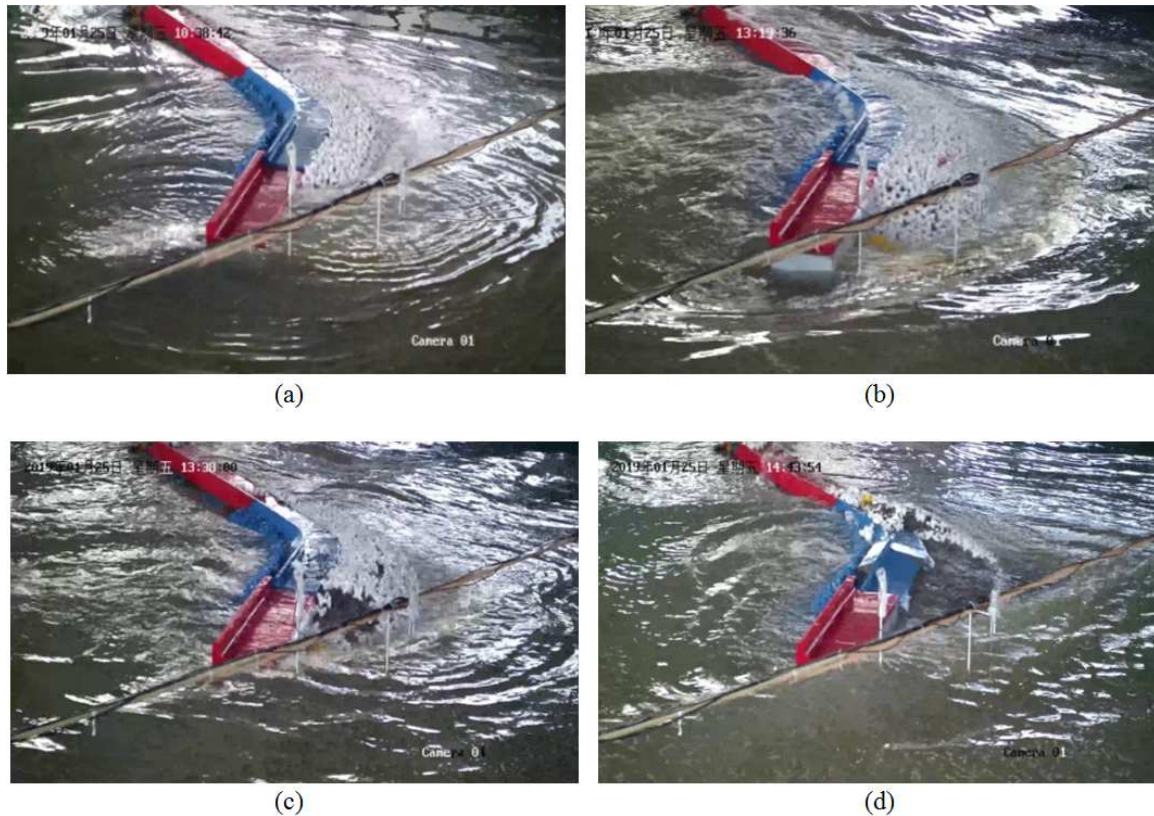
Figure 3. The test phenomenon of duplication test.

From 0:00 to 08:00, the breakwater remained stable at water levels from +2.31m to 2.61m, wave heights  $H_{13\%}$  from 4.02 m to 5.03m. (Figure 3(a)).

From 9:00 to 11:00, the 24t accropodes cover at the junction of the breakwater was began to be loose under the continuous action of the typhoon waves, which water level was +2.19m, wave height  $H_{13\%}$  was 5.91m (Figure 3(b)).

From 12:00 to 13:00, the gap width between the accropodes at the junction of the embankment was continued to increase under the influence of water level +2.13m wave height  $H_{13\%} = 6.91m$ , and the blocks were begun to unstable. During this period of continue wave action, the armor blocks were beginning to lose stability along the axis of the breast wall, and the core rocks under the armor were started to be scored and the failure area was increased (Figure 3(c)).

From 14:00 to 19:00, the armor blocks around the breast wall were continued to unstable, the connecting section of the breast wall was continued to collapse and core rocks were started underwashing, where the water level was +2.40m and  $H_{13\%}$  was 6.17m (Figure 3(d)).

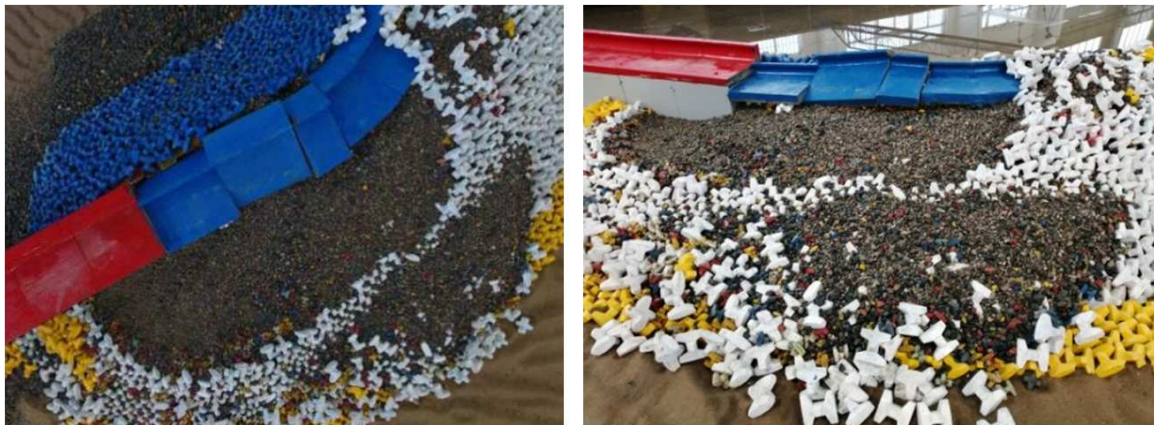
Figure 4. Failure layout of the breakwater.

Under the continuous action of subsequent water level and wave height, the damage of the armor blocks and the breast

wall were tended to steady state. After the experiment, the breakwater model was failure as shown in Figure 4:

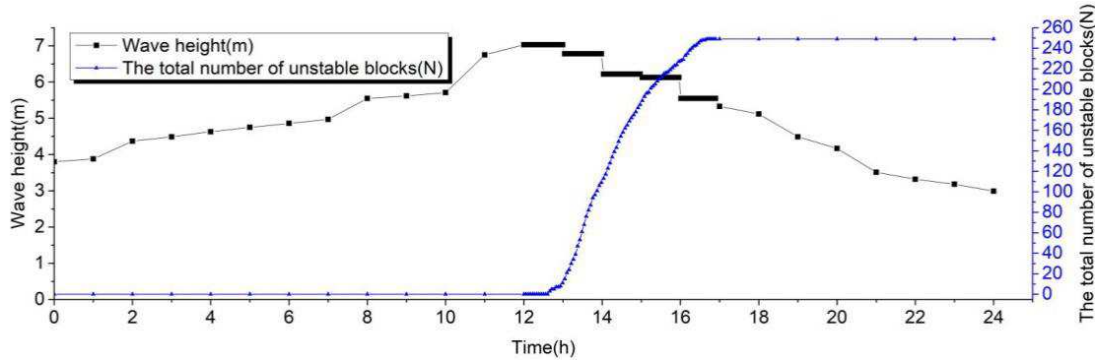
Figure 5. The variation of the wave height and the cumulative instability number of block during the test.

Figure 5 shows the variation curve of wave heights and the instability armor block number respect to action time. From

the figure, it can be clearly seen that the breakwater armor blocks remained stable until the maximum wave height coming, and the breakage time was concentrated between 12:00 to 17:00.

(1) From 12:30 to 13:45, the slope of the curve gradually increased, indicating that during this period the instability of the armor blocks were rapidly increased. The number of instability of the block at the same time interval was very different, and the destruction form was partial brittle failure. The brittle damage here means that a large number of armor

(2) From 13:45 to 16:00, the slope of the curve had a little change which indicated that the instability rate of the armor block was generally stable during this period. During the same time interval, the number of instability of the block was few different, and the damage form was ductile failure.

(3) After 16:00, the slope of the curve gradually becomes smaller and eventually becomes zero. At this time, the rate of increase in the number of instability of the shield block gradually decreases until the unstable block is no longer significantly increased, and the shield block is basically stable.

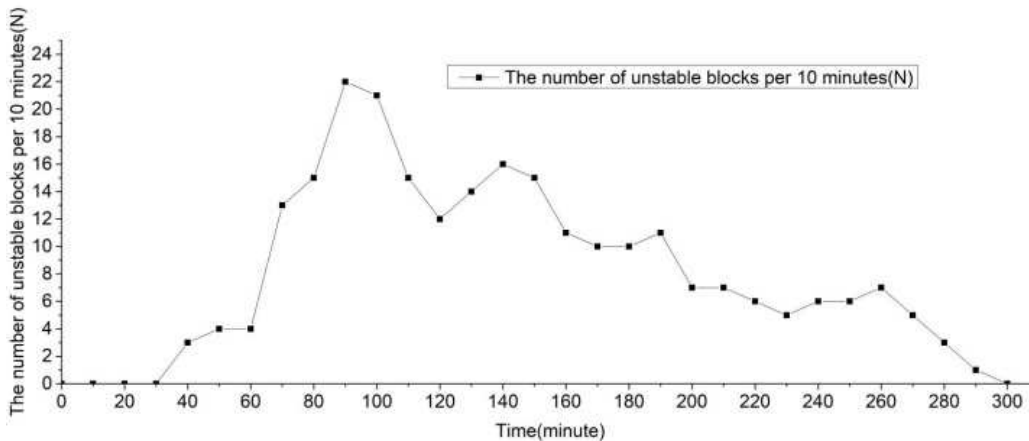
Figure 6. Number of block instability per 10 min during the destruction of the face.

(5) From 0 to 105 minute, the surface damage position was at the junction of the embankment head. During this period, the instability rate of the surface protection block sharply increased from 0 to a maximum of 22 blocks per 10 minutes, and the minimum was 3 blocks per 10 minutes, The damage speed of the armor surface changes significantly, so the junction of the head breakwater was a vulnerable area.

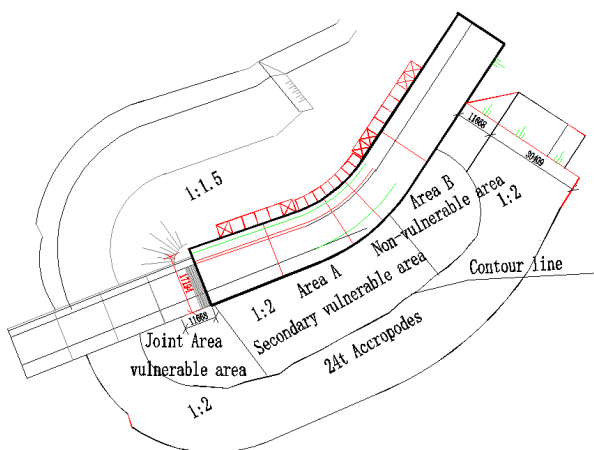
Figure 7. Distribution of destruction area division.

(4) Spatial distribution of slope breakage of breakwater was obtained. According to the experimental phenomenon, the surface protection block instability initially occurred at the junction of the head breakwater, and the next destruction position was developed along the axis of the breast wall toward the breakwater. Here, the damage rate of the surface is defined by the number of unstable blocks per 10 minutes and used as an evaluation index to determine the vulnerability of different positions of the slope breakwater. The damage rate of the surface is calculated from 12:00 to 17:00 (Figure 6). The surface damage location is divided into three areas: junction area at head breakwater, area A and area B as shown in Figure 7.

(6) In the period from 105min to 240min, the surface damage position is in area A near the breast wall. At this time, the surface protection block was mainly unstable due to the repeated climbing and falling effects of the wave cycle. The overall instability rate of the surface block was decrease. There are slight fluctuations in the period. The change in the damage speed of the surface is slightly eased, so area A near the wall is a sub-vulnerable area.

(7) In time from 240min to 300min, the surface damage position is in the area B. During this period, the rate of instability change of the surface block once again decreases to 0, so the B area near the wall is a non-vulnerable area.
