# The Acoustic Emission Testing Technology on Large Crane Structure Damage

Zhang Yanbing, Yang Li. The Acoustic Emission Testing Technology on Large Crane Structure Damage. *Engineering and Applied Sciences*. Vol. 5, No. 1, 2020, pp. 9-14. doi: 10.11648/j.eas.20200501.12

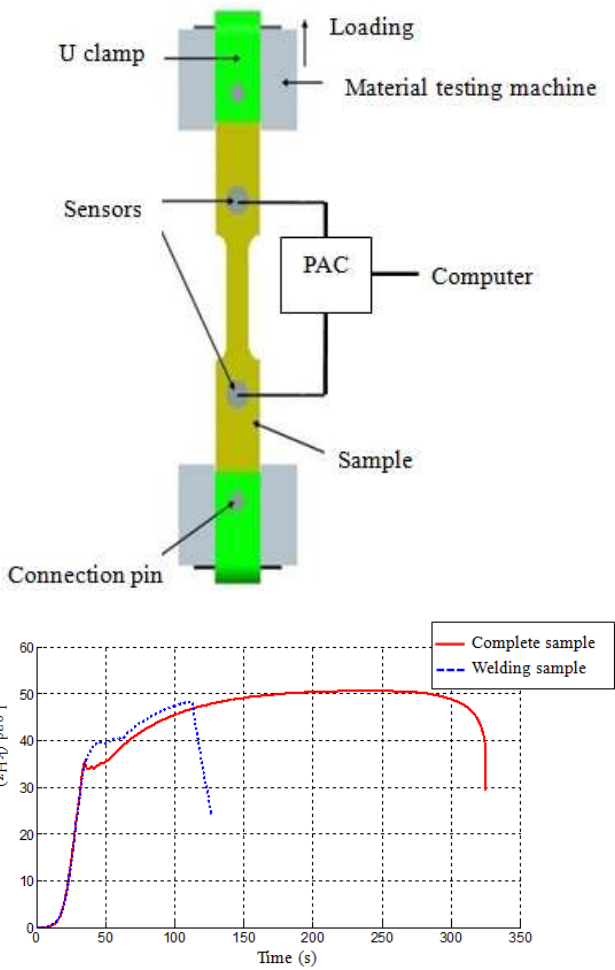
During the experiment, two channels are arranged at both ends of the sample, and I, II, III and IV are used to mark the four stages of material stretching [12], and the signal characteristics of each stage are analyzed. Comparing the tensile curves of the two samples (see Figure 1), it can be found that in the elastic deformation stage, the load time history curve of the two samples coincides completely because the non welded area mainly bears the occurrence of elastic deformation. However, due to the thermal effect of welding and the change of the internal structure of the material, the elastic deformation of the weld area is small at the low load stage. Moreover, the strength of the weld area is higher than that of the base metal due to the thermal effect of the welding process, so the yield limit of the welded specimen is higher than that of the complete specimen on the curve. On the other hand, the welding process makes the strength of the material increase while the molding decreases, or the maximum deformation energy reserve it can bear decreases, which leads to the shorter strengthening stage of the welding specimen, that is to say, the fracture occurs earlier.

Figure 1. Tensile specimen and its loading process.

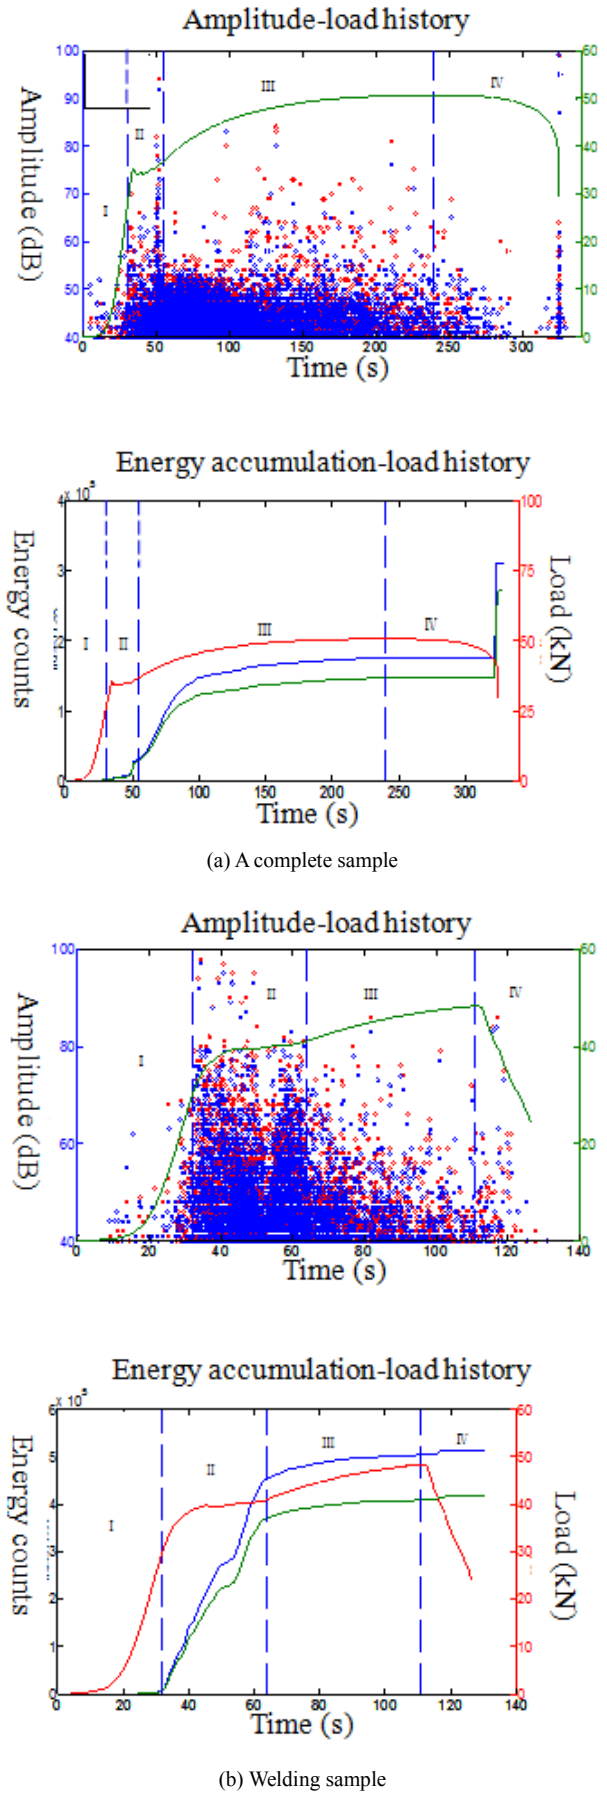
Figure 2. AE amplitude and ringing count-time history of tensile damage.

(1) Preload elastic deformation stage at this stage, the characteristics of the two samples are basically the same, almost few AE signal occurs, only under the load of more than 60% yield strength, there are a few signals. However, the energy rate, amplitude, ringing count, RMS, duration and other typical AE characteristic parameters are all at a very low level, which is still far from the typical defect extension signal [13]. This is mainly caused by the structural friction between the fixture, the pin shaft and the sample or the initial loosening of the gap between the internal tissues of the material. In General, this stage more reflects a friction damage process (see Figure 2).

(2) Plastic yielding stage in the early stage of stage II, the amplitude of the signal of the intact sample is relatively low, and the ring count is less. With the material yielding, a strong signal with a maximum amplitude of 94db appears at 50s, and the ring count value reaches a peak value of 1768. This is mainly due to the increase of dislocation motion, density, dislocation slip and dislocation avalanche in the yield stage, which leads to the intense energy release of the local stress field in the material. Furthermore, it is characterized by strong activation of AE signal, and when it reaches the upper yield point, the activity and energy value of AE signal reach the peak value.

In the stage I, due to the thermal effect of the welding process, the upper yield point of the welding sample is increased, and the total time of the yield stage is extended. In this stage, the intensity and activity of the AE signal are also higher. In this stage, the two samples show the following characteristics: the number of impact, amplitude and ring count rate of welded samples are higher. This is because the local materials in the welding area achieve a transformation similar to heat treatment strengthening under the action of

high temperature, which leads to the need for higher load to reach the yield stage. Secondly, during the process from the upper yield point to the lower yield point (in the 50s), AE parameter values dropped rapidly and there was a short "trough". After passing the lower yield point, the activity of AE signal begins to increase again, but the maximum value is lower than that before the upper yield, which is called "double peak" phenomenon [14].

(3) Reinforcement stage in the third stage, due to the effect of work hardening, the density of dislocations in the material increases, and dislocation packing, entanglement and splitting occur between the metal lattices, which greatly increases the difficulty of dislocation movement, and ultimately increases the load required for the specimen to continue to deform. In the early stage of this process, AE signal has a strong activity, but the amplitude has a very significant decline compared with the yield stage. At the later period of this stage, the AE signal quantity is obviously reduced, and its overall magnitude is gradually reduced. Compared with the two samples, the acoustic emission signal characteristics of the two samples are basically similar at this stage.

(4) Local necking stage at this time, it can be seen from the load curve that the load on the specimen is gradually decreasing, and there is almost no acoustic emission signal in the process, but a very strong transient impact occurs at the moment of specimen fracture.

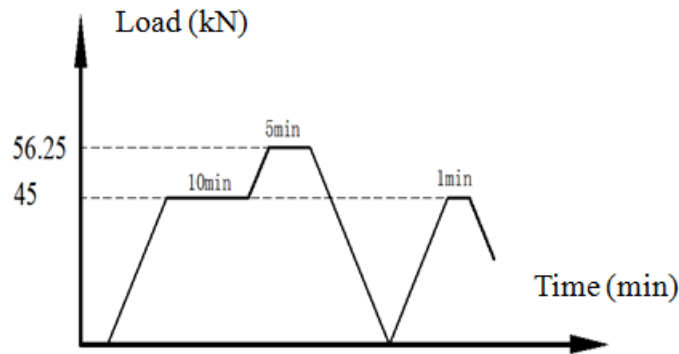
Figure 4. AE test loading program.

During the static load test of the crane, the whole process of on-line detection is divided into two loading cycles (see Figure 4). In the detection results, the dotted line is used as the time separation, and the lifting and braking are started according to the time sequence.

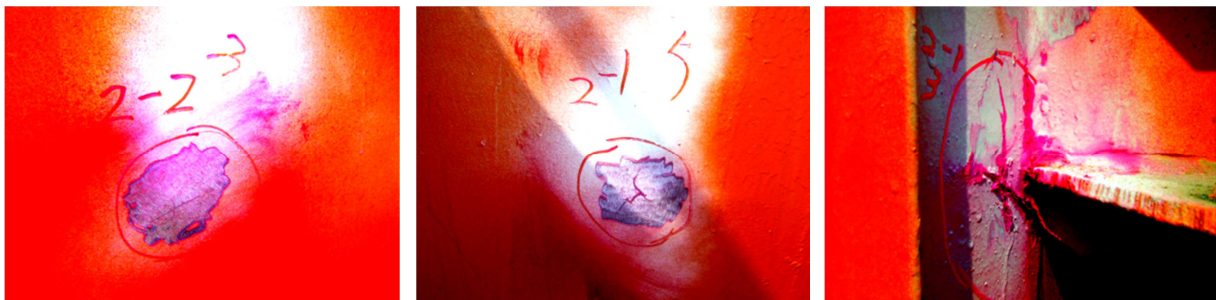
Figure 8. Cracking defects of the main beam of the rotating platform.

(2) Grinding and penetrant flaw detection were carried out on the rotary girder found in the acoustic emission detection process of the actual gantry crane. Multiple surface cracks and obvious cracks were found on the outer surfaces of the two box girder under the rotary platform (sensors were placed above the girder, i.e. in the top machine room) (see Figure 8). The reason is that this area is the web position of the main beam of the rotary table. Because it bears the cyclic load during the frequent lifting process of the crane for a long time, and this area is located in the stress concentration area of the cantilever beam root, the fatigue damage finally produces cracks.
