# Analysis of the Power Plant Breakwater Failure Subjected to Typhoon Mangkhut Based on Model Experiment

Qie Lu-wen<sup>1</sup>, Wang Chao<sup>1,2</sup>, Luan Ying-ni<sup>2</sup>, Chen Song-gui<sup>2</sup>, Chen Han-bao<sup>2</sup>

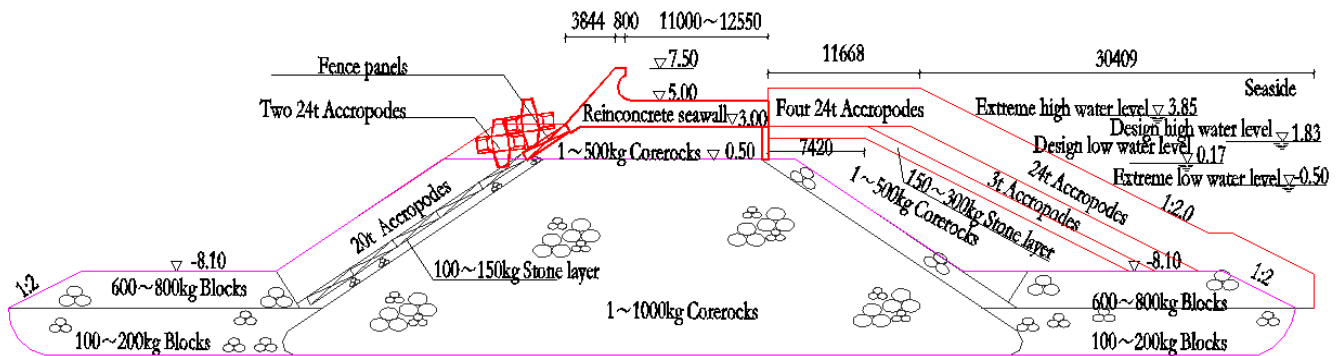
Figure 1. Cross section drawing of the breakwater.

The breakwater consists of a caisson breakwater and a mound breakwater, of which the caisson breakwater with a length of 56M was arranged at the head part of whole structure. The cross section drawing is shown in Figure 1. The model is designed according to the gravitational similarity criterion. The structural section size is designed according to the geometric similarity criterion. The model similarity scale is 1:43.
